River Bank Management *Overshading*

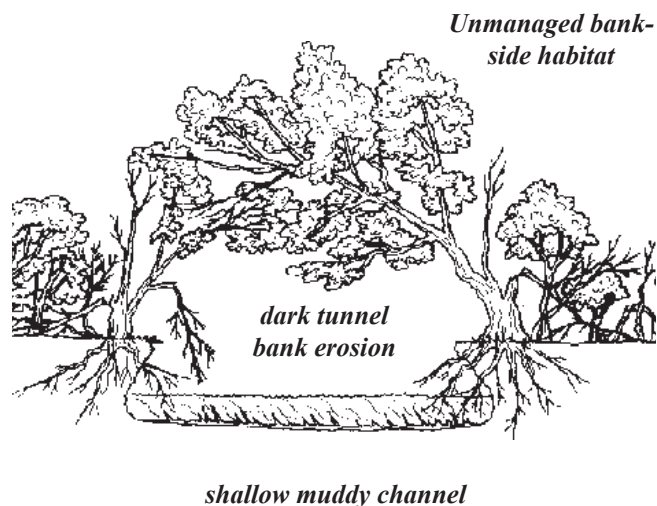
This practice has lapsed on many farms and the river channel has become a dark tunnel beneath the tangled tree branches.

This shading reduces grass and shrub growth on the banks which are then exposed to the eroding forces of the river.

In these situations the channel can become wide, shallow and full of silt from the eroding banks.

Fish and wildlife habitat can be improved by reinstating the coppicing of the bankside trees.
